Case Study: Greenville Bridge Rehabilitation Slip-Lining to Stabilize Stone Masonry Culvert, Smithfield, RI

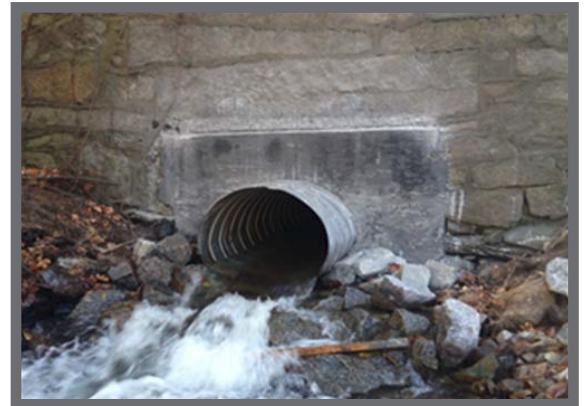
Outfall of the newly relined stone masonry culvert completed as part of the reconstruction of Route 44 in Smithfield, Rhode Island near Smith Avenue (Route 116).

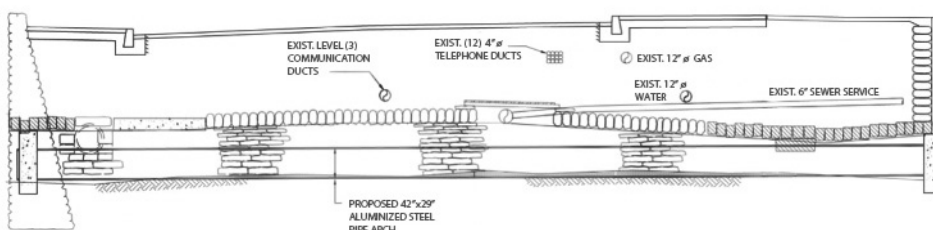
Before - Stone Masonry Culvert
5' span, 3' rise (assumed avg.)
Manning's roughness, $n = 0.04$
Slope at 0.5% (assumed avg.)
Hydraulic capacity ~ 55.14 cfs

After - Spiral Rib Pipe-Arch
42" span, 29" rise
Manning's roughness, $n = 0.012$
Slope at 0.61%
Hydraulic capacity ~ 55.20 cfs

The 42" x 29" pipe-arch was an ostensible reduction in waterway from the geometrically averaged 5' x 3' stone box culvert ($6.5'^2$ vs. $15'^2$), but a slight increase in grade (0.5% to 0.61%) and a marked improvement in the roughness coefficient (0.040-rough rock vs. 0.012-spiral rib pipe) provided the needed hydraulic match.

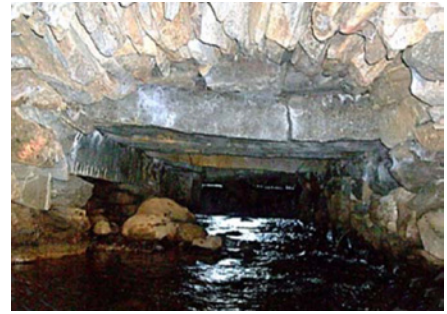
Modifications to the existing channel were needed to accommodate the slip-lining process, primarily the creation of additional vertical clearance in an area. Preparatory work included obstruction removal, void blocking/filling and streambed regrading. The photo at right illustrates the variable nature of the channel cross-section and the challenges presented both in design and construction.
